Upper Rideau Lake Shoreline Assessment Summary Report

June 2015

Submitted to the Upper Rideau Lake Association by Watersheds Canada

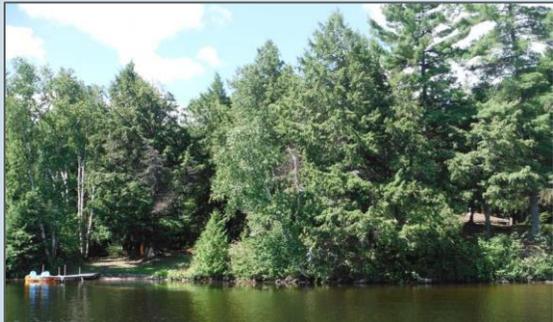
Classification & Description	Photograph Example*
<p>Natural – A healthy buffer of vegetation and/or a natural shoreline of sand or exposed rock that is undisturbed and undeveloped.</p>

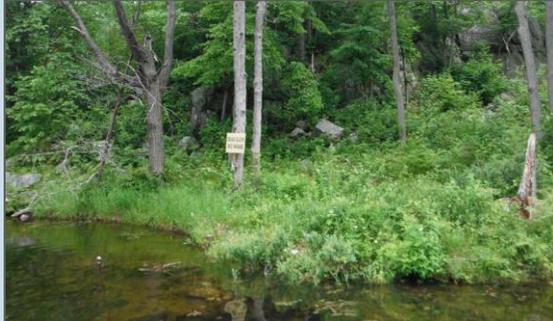
<p>Regenerative – Natural vegetation has been removed in the past, but is in the process of growing back towards a natural state.</p>

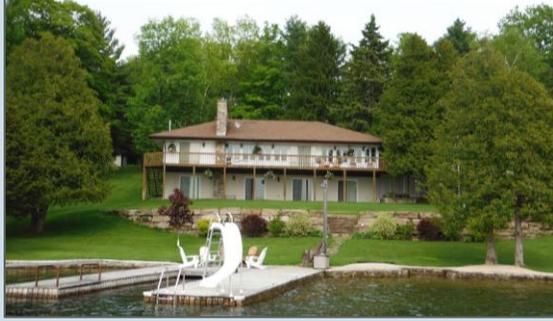
<p>Ornamental – All natural vegetation has been removed and replaced with mowed lawn and other non-native vegetation; structures such as docks, decks, boathouses and boat ramps are predominantly present at the shore.</p>

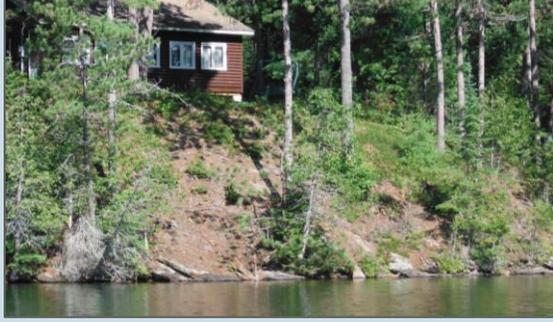
<p>Degraded – Natural vegetation has been lost; soil erosion, undercutting of the bank, and/or exposed roots of shrubs and trees are significant.</p>

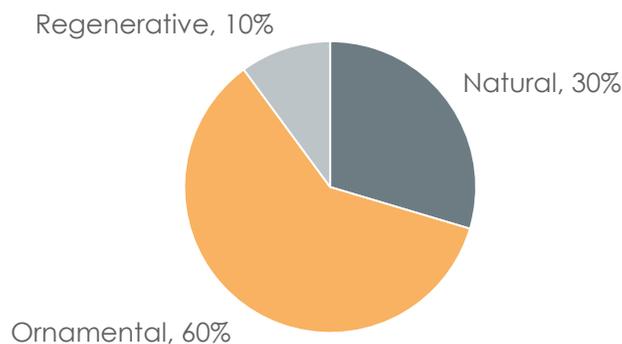
Figure 1 Property Classifications

On Upper Rideau Lake, the majority of the shoreline (60%) is classified as ornamental, followed by 30% being natural and 10% being regenerative. It is recommended that shoreline property owners engage in naturalization projects to further decrease the ornamental percentage and increase the regenerative and natural percentages.

This finding presents an opportunity for residents of Upper Rideau Lake to enhance the overall quality of the lake by maintaining more natural shorelines. To restore shorelines to more natural states, property owners are encouraged to take action.

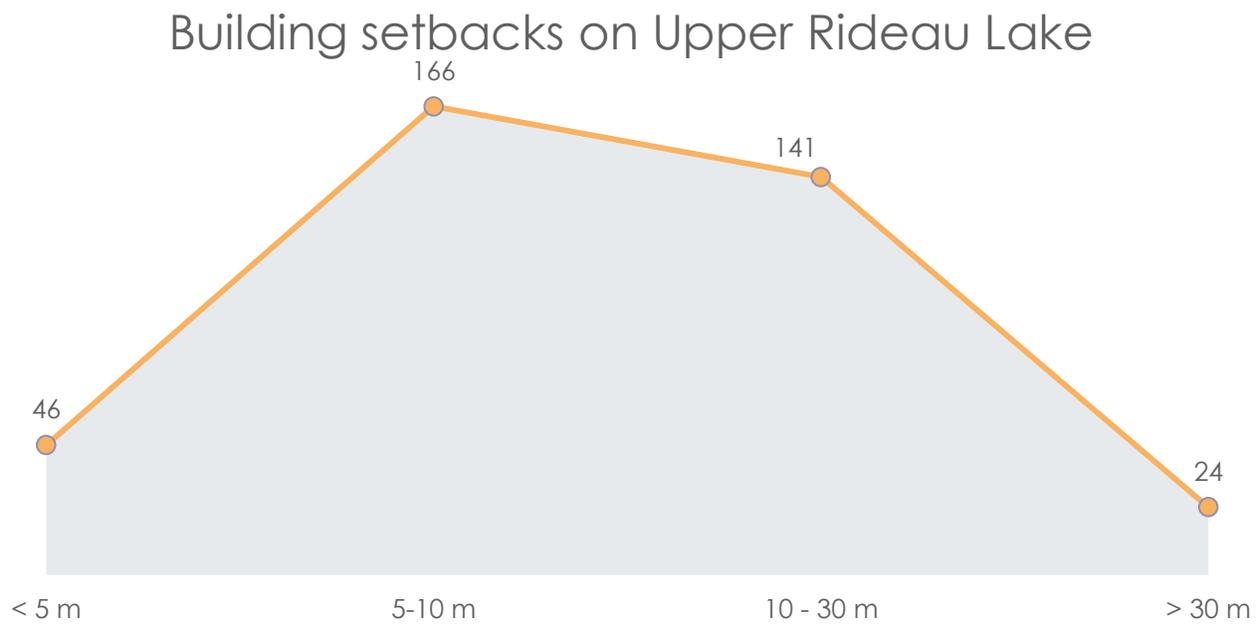
Figure 2 Building Setback Ranges

On Upper Rideau Lake, properties with various building setback ranges were observed and recorded. Shown in figure 2 is the range of building setbacks for properties on the lake. Building setbacks for shoreline developments in Ontario should be at least 30 metres from the high water mark; however, older cottage buildings were permitted closer to the high water mark. On Upper Rideau Lake, 93% of the properties surveyed were observed to be closer than 30 metres to the shoreline. These tend to be cottages or cottages re-developed into homes that were originally built when cottage developments were permitted closer to the water’s edge. The primary problem associated with near-shore building setbacks is the limited area to buffer or filter contaminated runoff and wastewater from the main dwelling. They also disrupt the nearshore habitat corridor that many different animals use to move around the lake environment and into upland areas. While moving these buildings further back from the shoreline may not be a feasible or realistic option, naturalizing the shorelines of these properties would help address this issue.

A potential area of concern with building setbacks is having septic systems installed close to shore. Regular inspections and maintenance of septic systems can help prevent excess nutrients from entering the lake. Nutrients entering the lake can contribute to eutrophication, resulting in increased aquatic vegetation, low oxygen levels and algal blooms. Excess nutrient loading is one of the largest threats to water quality in lakes and rivers; it is everyone’s responsibility to do something to help protect the lake.

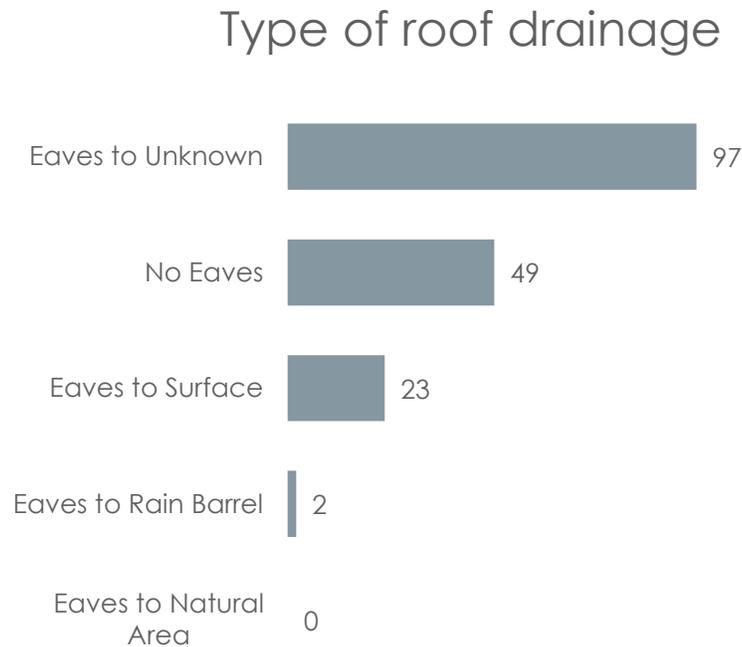
Figure 3 Roof Drainage

Only two properties on the lake were identified with having eaves that drain into a rain barrel and no properties were identified with eaves that drained into a natural area. These numbers may be higher, as there were nearly 50 properties where we were unable to identify from the water where the eaves drained to. Because rain barrels are bulky to transport to a cottage area, the lake association may look into ways to make them more available to shoreline property owners. Another option is to install French drains next to cottages to encourage water to percolate into the ground instead of running directly overland into the lake.

Naturalizing shorelines on properties with near-shore building setbacks would help reduce runoff from entering into Upper Rideau Lake, which could help reduce potential problems such as algae blooms and loss of oxygen in the water. Property owners can also manage this problem by ensuring they have eaves troughs with downspouts directed at natural or stone catch basins or rain barrels, as well as ensuring they have a properly functioning septic to process wastewater before it enters the lake. As septic systems do very little to process nutrients, it is also important to use phosphate free products.

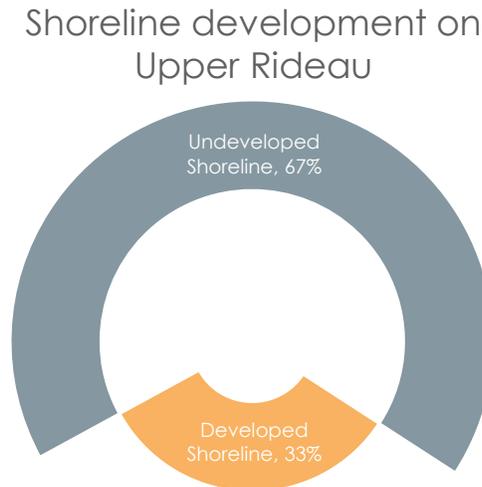
Figure 4 Shoreline Development Percentages

On Upper Rideau Lake, 33% of properties with shoreline development features were observed and recorded within 3 metres of the lake. Shoreline development included the presence of man-made structures on the land or in the water within the first three metres of the shoreline. The diagrams below show the common structures present on the lake, as well as the total shoreline development.

It is recommended for the health of a lake to aim for a no more than 25% of the shoreline developed for access to the lake and recreational space leaving the rest natural. Beyond 25% development, critical functions of the lake that maintain its ecological integrity can begin to fail (Environment Canada, *How Much Habitat is Enough?* 2013) Therefore, 75% of the shoreline should be left in a natural state in order to provide maximum benefit to the health of the lake. Figure 1 shows the percentage of the entire assessed shoreline in each classification.

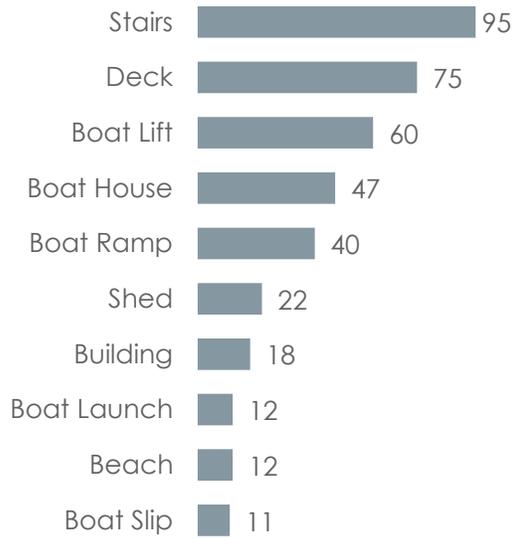
Figure 5 Structures On Lake

Shoreline development structures can, contribute to erosion, and can restrict wildlife access to and from land and water. Although some of these types of structures can have negative environmental impacts because they cover habitat, this can be partially mitigated by allowing vegetation to grow around the decks, boathouses, sheds, stairs, or other man-made structures.

Development along a shoreline can be done sustainably and in an environmentally sensitive fashion, as long as the structures are maintained and kept to a minimal footprint on the waterfront.

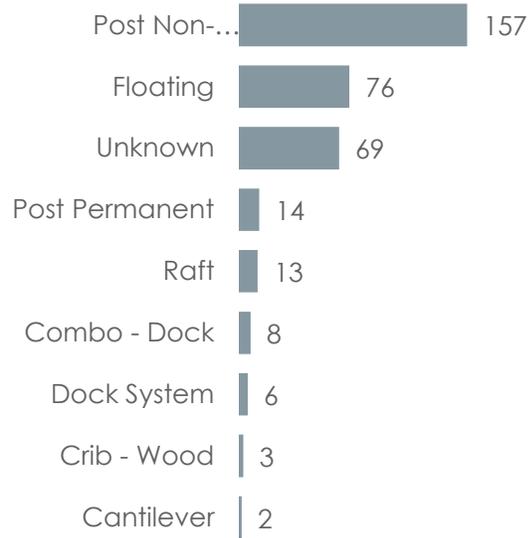
Figure 6 Docks on Lake

Small floating or post non-permanent docks are the best choice of docks as they have minimal contact with the lake bottom, and sit on or out of the water, which reduces the impact they have on the surrounding environment. In the future, if shoreline property owners need to replace their old or failing permanent post, solid, or crib docks, they could consider a non-permanent post dock or floating dock, limiting impacts to fish habitat and ensuring the natural flow of water remains unrestricted.

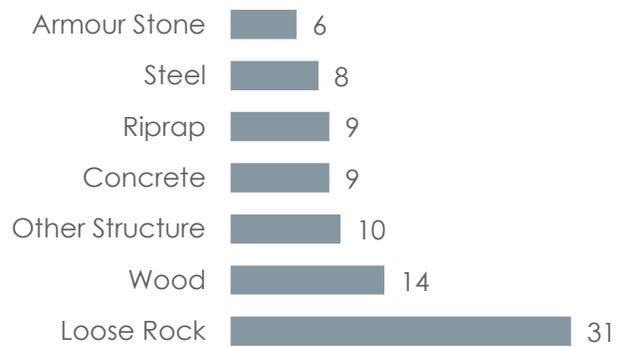
Figure 7 Retaining Walls on Lake

On Upper Rideau Lake, the number of properties with retaining walls was counted and summarized below. Retaining walls, most often built to protect against erosion are a common feature on many lakes. The estimated length of retaining walls on Upper Rideau Lake is 18% of the total shoreline. The types and frequency of retaining walls is below in figure 7

382 properties on Upper Rideau Lake, or 82% of properties assessed, do not have a retaining wall. Of the retaining walls that are present the most common choice was loose rock (31 properties or 6% of properties assessed), followed by concrete (14 properties or 3% of properties assessed). While retaining walls were a common choice in the past to combat erosion, we now know about their impact to the natural environment. Waves and wakes are reflected back from flat, hard surfaces with the same force as they strike the wall. This can cause excess turbulence in the water, which scours the sediments from the lake bottom. Solid walls also eliminate shoreline habitat and act as a barrier, preventing wildlife from reaching the water. Although some retaining walls such as rip rap have fewer impacts than other retaining walls, shoreline property owners could consider alternative erosion control methods such as planting vegetated buffers or shoreline bioengineering if they ever wish to replace their current, old, or failing retaining wall. In the meantime, maintaining vegetation around the wall and allowing new vegetation to establish and grow will help reduce runoff and provide habitat for wildlife.

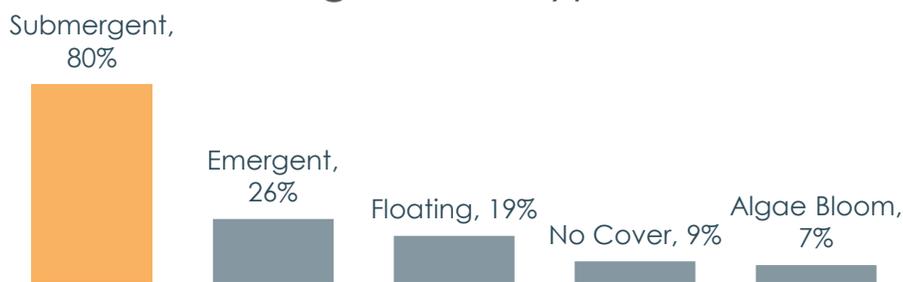
Figure 8 Aquatic Vegetation

On Upper Rideau Lake, the number of properties with aquatic cover were observed and summarized. The presence and abundance of aquatic cover can vary throughout the year. Each assessed property could have one or more types of aquatic cover. Figure number 8 shows the percentage of properties on Upper Rideau Lake had aquatic cover listed by type observed along their shoreline during the time of the assessments:

80% of properties on Upper Rideau Lake had submerged aquatic plants which are an important source of habitat for fish, and other aquatic organisms. Emergent and floating vegetation was found less frequently on Upper Rideau Lake but is still an important part of the aquatic ecosystem, giving habitat to birds, frogs, dragonflies, and other wildlife. Aquatic cover can create places for wildlife to lay their eggs, provide a perch for predators of fish and insects and offer cover for wildlife. Shoreline property owners that are removing aquatic vegetation from their shoreline properties may be indirectly increasing the presence of invasive aquatic species. Aquatic vegetation may be a problem if there is an overabundance of it due to high nutrient levels entering the lake through runoff. By controlling nutrients entering the lake through well vegetated buffers and other actions shoreline property owners can maintain a healthy balance of aquatic habitat, and space for recreational activities.

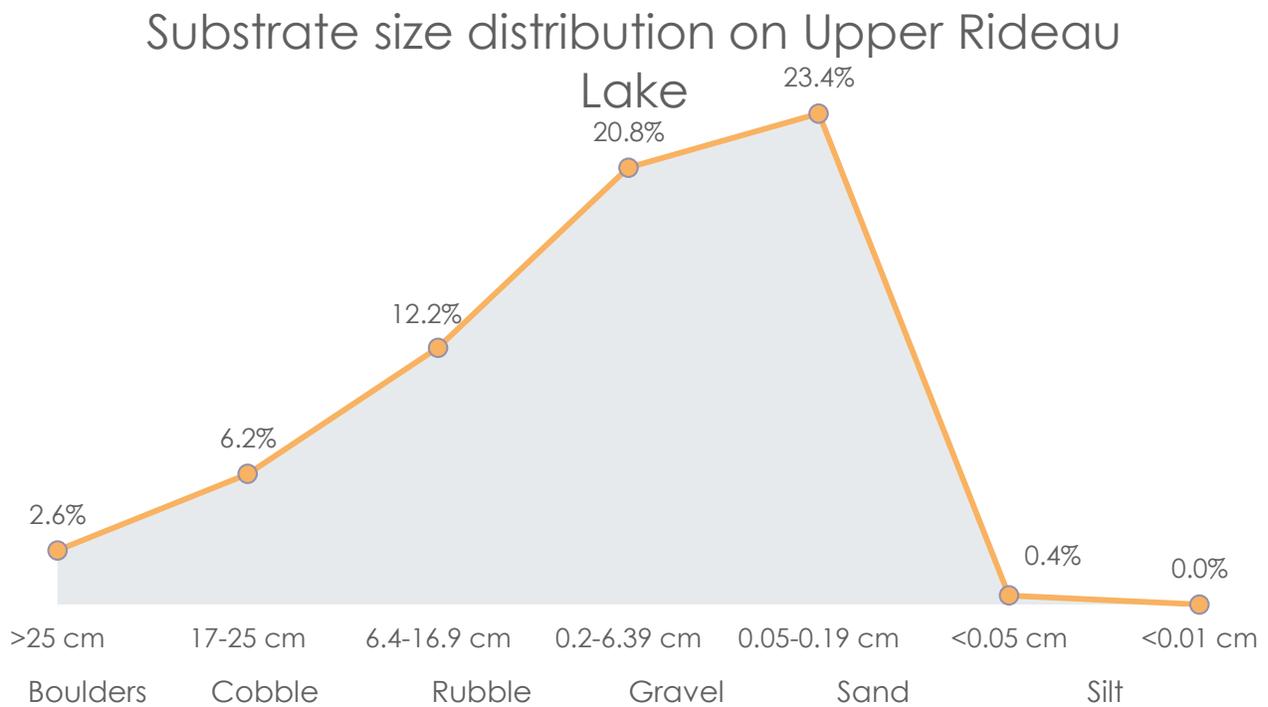
Figure 9 Sediment Distribution

On Upper Rideau Lake, the aquatic substrate types were observed at each property. Figure 9 is the substrate size distribution on Upper Rideau Lake. Aquatic substrate can be important habitat for fish and other aquatic wildlife and it is useful to document this feature to better inform future restoration projects on the lake. Upper Rideau Lake was found to have a good variety of aquatic substrate throughout the lake for supporting aquatic biodiversity. Rubble and cobble provide great habitat for crayfish and spawning grounds for various species of fish while other environments provide excellent substrate for diverse aquatic vegetation.

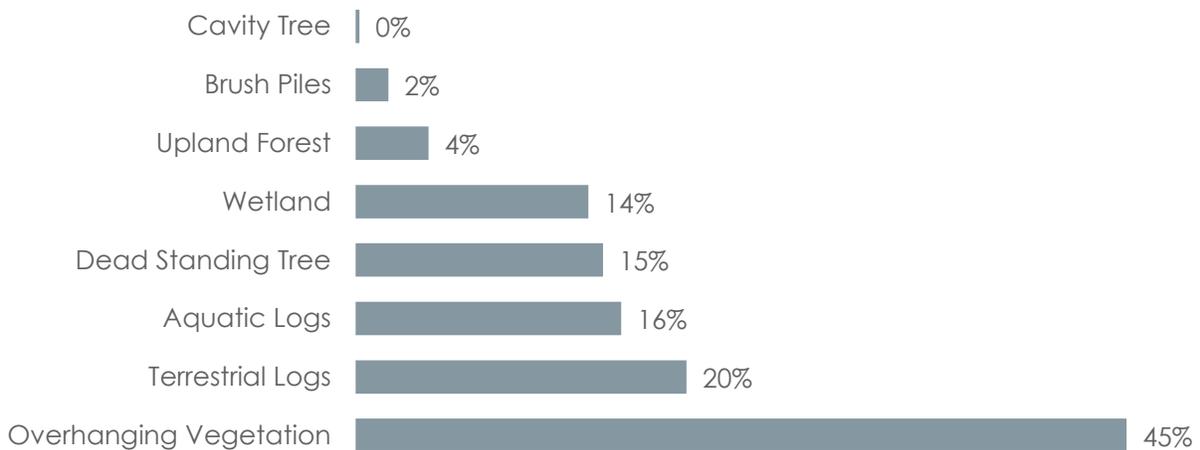
Figure 10 Habitat present

Most common types of nearshore habitat on Upper Rideau Lake was overhanging vegetation, followed by terrestrial logs. Most properties on Upper Rideau Lake had some amount of terrestrial habitat present. Wildlife provides us with many enjoyable and beneficial activities from bird watching and wildlife photography to pest control, seed dispersal, nutrient cycling and pollination, to name just a few. It is important for there to be a rich and diverse range of habitats along the lakeshore to ensure a healthy lake environment. Figure 10 summarizes the lake nearshore habitat.

It is important to leave large trees that are dead and dying in place, as they provide important habitat for a number of different species. In Ontario, more than 50 species of birds and mammals depend on cavity trees for nesting, rearing young, roosting, feeding, storing food, escaping predators, and hibernating. Fallen logs on land provide habitat for small mammals such as moles, woodpeckers, toads and insects. As the log decomposes, reptiles and amphibians lay their eggs in the moist wood. A decaying log is also great habitat for beetles, and ants that burrow under the bark and lay eggs. In the water, logs provide important fish habitat by providing refuge for small fish, and spaces for ambush predators such as pike to conceal themselves. By leaving dead and decaying brush and logs in place, you are helping contribute to a healthy and vibrant species community.

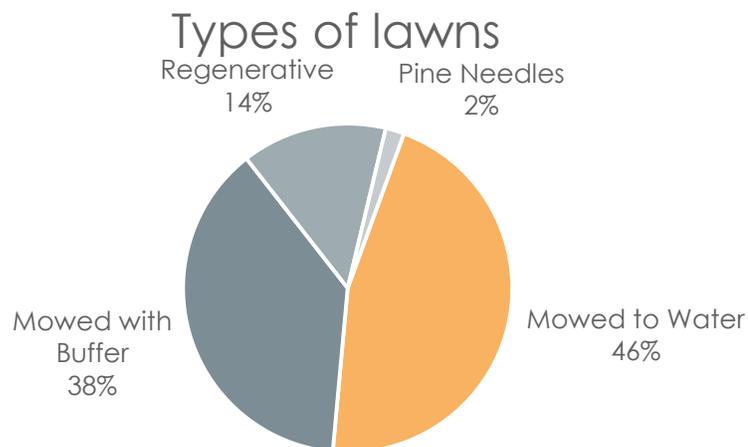
Figure 11 Lawn Types

On Upper Rideau Lake, the number of properties with lawns, either mowed or regenerative, was observed. 46% of properties with lawns were observed to have a mowed lawn to the water’s edge. Natural ground cover and native vegetation, in comparison, slows runoff and allows filtration, removing many contaminants, pollutants, nutrients, sediment and other substances. These substances can be carried into the lake by runoff and can harm water quality and local ecological integrity. Lawn grasses also have short root systems and do not bind the soil well, which can lead to problems with erosion.

In areas close to shore, a lawn is generally not a good choice of ground cover as 55% of precipitation runs off mowed grass directly into the lake, instead of returning to groundwater. If shoreline property owners wish to mitigate this, they could consider allowing vegetation to regenerate on its own or by actively planting native trees, shrubs, grasses, or alternative ground cover. The roots of the vegetation will grip the soil, which can help prevent erosion. Allowing mowed lawns to regenerate to a more natural state promotes water conservation and protects surface and groundwater resources. Properties with regenerative lawns are encouraged to allow this natural process to continue and to enhance regeneration by planting native shrubs and trees.

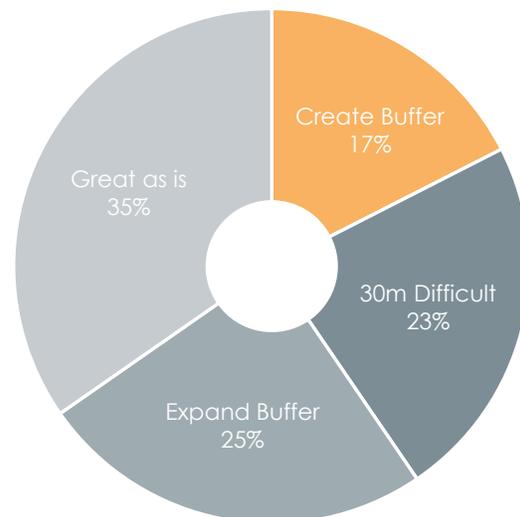
Figure 12 Buffer Recommendations

Arguably the most important element of a shoreline that property owners can easily influence is shoreline buffers. Buffers are an important element of natural shorelines that help filter nutrients, reduce erosion, and provide habitat. On Upper Rideau Lake, 17% of properties have enough room between the main residence and the lake for the creation of a shoreline buffer to provide benefits to water quality and habitat. 35% of properties were noted to have great buffers as they are. In order to ensure the sustainability of a healthy lake environment it is important that natural buffers make up at least 70% of the lake shoreline, preferably as much as 80%.

- Priority 1: The best candidates for naturalization efforts. These properties have more than 50% of their shoreline classified as ornamental. Additionally these properties have at least 30 metres of space between the water's edge and their main building (house/cottage). These properties are recommended to either create a buffer or expand their current buffer.
 - These shoreline property owners are encouraged to naturalize their shorelines, because their efforts would have the greatest overall impact on the health of their shoreline and the lake. They have an opportunity to plant a healthy buffer of native vegetation that could be 30 metres wide. When designing a planting plan, they can maintain room for access to the water (via raised staircases or covered, curved pathways).

There are a number of options shoreline property owners have to improve or increase the size of their buffer. Rideau Valley Conservation Authority in Partnership with Watersheds Canada and the Canadian Wildlife Federation is offering shoreline naturalizations funded through the Department of Fisheries and Oceans Canada. The data collected previous in this report was used to calculate shoreline naturalization priorities. The categories are as follows:

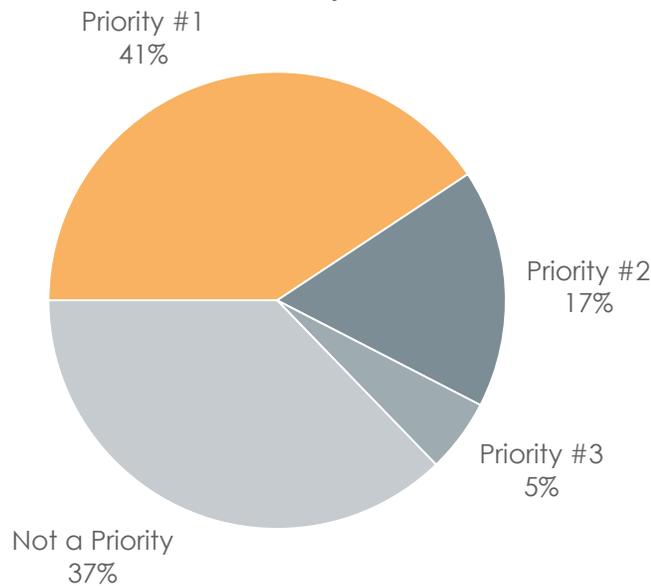
Figure 13 Naturalization Priorities

- Priority 2: The second best candidates for naturalization efforts. These properties have more than 25% of their shoreline classified as ornamental. However, some of these properties have less than 30 metres of space between the water’s edge and their main building (house/cottage), which could make planting more difficult or less substantial. These properties are also recommended to either create a buffer or expand their current buffer.
 - These shoreline property owners are encouraged to plant vegetation where they can; e.g. around decks, docks, boathouses, stairs, and pathways. Although 30 metres of space between the water’s edge and the main building may not be available, increasing the amount of native vegetation within the available room would still contribute to a healthier shoreline and lake.

- Priority 3: These are the third best candidates for naturalization efforts. These properties are already mostly natural or regenerative, and less than 25% ornamental. However, some of these properties have less than 30 metres of space between the water’s edge and their main building (house/cottage), which could make planting more difficult or less substantial.
 - If these shoreline property owners wish to enhance their native vegetation to even further reduce their ornamental classification, their efforts would still contribute to an even healthier shoreline and lake.

There is huge potential for shoreline naturalization on Upper Rideau Lake as greater than 50% of the properties on the lake could potentially be good candidates based on our assessment for shoreline naturalization projects. Buffer zones are the ribbon of life, providing over 90% of aquatic and terrestrial wildlife with essential habitat

needed at some point throughout their various life stages, to mate, rear young, find food, or take shelter. Property owners who do not have 30 metres of space inland from the water's edge are encouraged to plant where they can. If support is needed in naturalization efforts, Rideau Valley Conservation Authority offers a shoreline naturalization program with a complimentary site visit, subsidized plant costs, and project planning assistance. For more information, visit www.rvca.ca or www.watersheds.ca
